# Immediate Post-Extraction In Situ Direct Lamination Composite Bridge

Ron Carlson, DDS

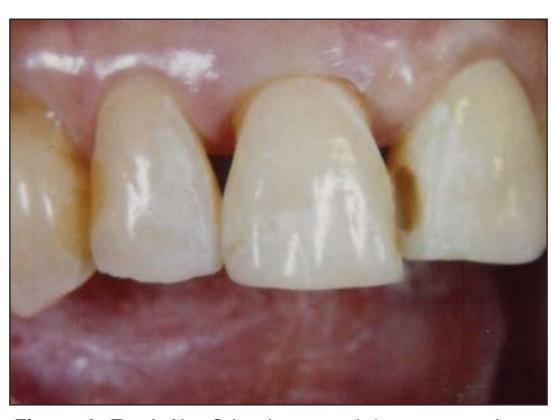
Figure 1. Tooth No. 8 is abscessed, hypererupted, rotated facially, and requires immediate extraction.

In Figure 1, the patient's tooth No. 8 must be removed immediately. It had been treated endodontically years ago and developed apical pathology. The patient had pain, swelling, intense drainage, and malodor. The incisal migration and rotation facially is notable. This condition interfered with occlusion to such an extent that the patient was prevented from closing the molar teeth together in chewing.

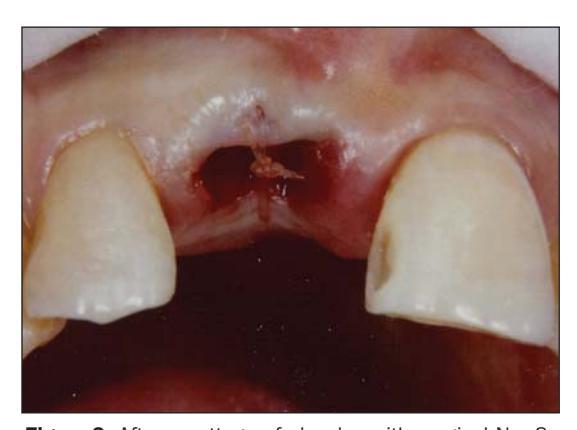
**Figure 3.** After curettage of alveolus with surgical No. 8 round bur and hand instruments, a 4.0 resorbable suture is placed to secure the wound. Before extraction, the old mesial resin filling had been removed and teeth Nos. 7 and 9 cleaned with pumice and diamond burrs.

Figure 3 shows the wound site and the resorbable suture holding the margins together. Prior to the extraction of tooth No. 8, teeth Nos. 7 and 9 were cleaned with pumice. The old, stained mesial-facial filling was removed prior to PEB in situ fabrication, before the stent fabrication, and before the bridge was constructed.

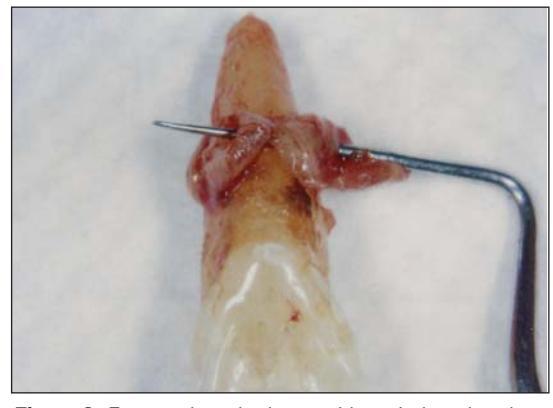
Figure 2. Extracted tooth shown with periodontal probe piercing abscess attachment at mid-root level.

Figure 2 is a closeup view of the extracted tooth with a periodontal probe piercing the soft tissue attached to the mid-root level. After the tooth was removed, it was sent to Queen's Hospital in Honolulu, Hawaii for histopathological review by a board certified pathologist, disclosing an endo-perio abscess.

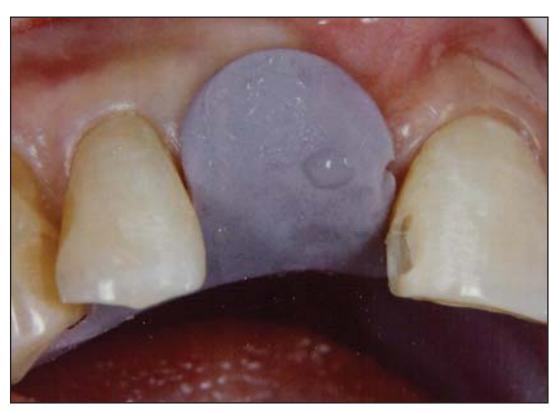
**Figure 4.** The CS is constructed with impression putty mixed by hand and placed from the lingual-palatal extending toward the labial vestibule, as seen here, to form the facial platform.

The Carlson Stent (CS) was next constructed at chairside. Impression putty was mixed by hand and placed from the lingualpalatal extending the facial platform toward the labial vestibule, as seen in Figure 4. (Note: In construction of the PEB for this circumstance, the lingual aspect was used for the majority of the support and attachment of direct composite filling material to support teeth Nos. 7 and 9. One may note in Figures 5 to 9 that the facial margins are minimal, ending at the facialmesial line angles of teeth Nos. 7 and 9. Not shown is the lingual thickness, or "lingual wings," embracing the lingual concavities.)

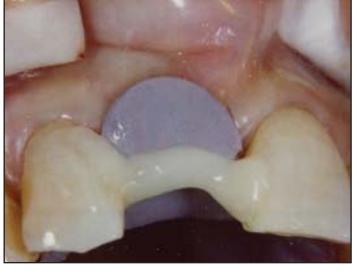
**Figure 5.** After etching Nos. 7 and 9 and applying clear resin adhesive, the substructure composite is laminated from Nos. 7 to 9 and cured thoroughly.

A layer of "substructure" composite was laminated from the mesial of tooth No. 9, filling the old restoration defect, to the mesial of tooth No. 7. An E-1 and porcelain filling instrument may be used to obtain a thick base and ensure composite adaptation to the enamel of the support teeth over the stent (Figure 5).

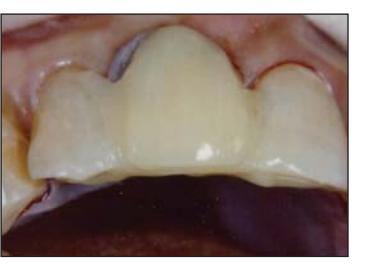
Figure 6. Specific and multiple laminations of substructure and superstructure composites are made to lingual and proximal-facial surfaces of Nos. 7 and 9.

The lamination phase was next, with the application of "superstructure" composite. During this phase, various shades and characterizations may be employed to the satisfaction of the patient and doctor. Figure 6 shows the overbuilding of the free-hand "composite pontic," which shall be finished either before or after removal of the Carlson Stent.

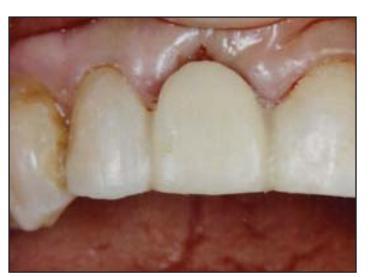
**Figure 7.** The CS is removed and the pontic and attachments are shaped, shaved, contoured, and polished with a series of coarse to fine diamonds. Polishing is done with cocoa butter and Berlew Sulci Wheels (Jelenko Dental Health Products).

With course and fine finishing diamonds, removal of excess composite flashings was made around the abutment teeth Nos. 7 and 9. While the Carlson Stent was still in position, contouring of pontic No. 8 was also done. After preliminary finishing, the stent was removed, and the lingual margins were rounded, smoothed, and polished. Also, during initial finishing with ultrafine diamond burs, a rubber polishing wheel and cups were used to bring composite surfaces to a smooth, finished condition, seen in Figure 7.

The occlusion and incisal guidance were easily established at this time. Care was taken not to "over finish" the PEB or press beyond the patient's physical and emotional limits of endurance. In the 2 hours during this procedure the infected tooth was removed, the endo-perio abscess was cleaned from the alveolus of tooth No. 8, the replacement prosthesis was constructed in situ, and the direct composite bridge was finished. One must not minimize the challenge to the patient during this procedure. The interim finish is seen in Figure 7.

The patient is instructed in the care and maintenance of the PEB before and after the initial placement appointment, and again at the final finishing appointment about 2 to 8 weeks later. Due to remodeling of the alveolar bone taking place over 2 to 8 weeks, a greater space will develop between the gingival side of the PEB than already exists, due to the stent's thickness (Figure 7).

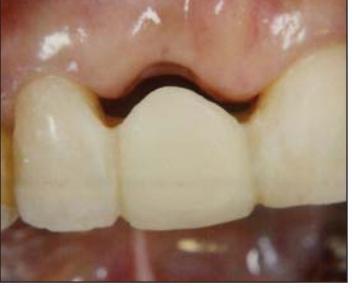
Figure 8. About two weeks after Carlson Bridge fabrication the infrapontic area is cleaned, shaped, etched, silanized, and retrofilled with superstructure glossy composites of appropriate shade.

Figure 8 shows the gingival remodeling about 2 weeks after the PEB procedure. Bone loss will vary in each case and so will the amount of tissue reconfiguration.

In some instances, the initially placed PEB needs no post-treatment augmentation in the infra-pontic area. However, this is quite rare. In this case, there was approximately a 2-mm defect at this time (Figure 8), which was easily closed with the addition of composite at the gingival margin of the PEB, after cleaning and treatment with coupling agents.

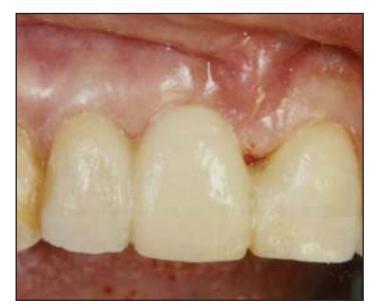
Figure 9. The finished PEB, or Carlson Bridge, may be changed at any time in the future with the addition of composites. Repairs or refurbishment years later can be done easily in situ. As an alternative approach, the direct composite bridge offers many advantages to both patient and doctor.

Once composite was added, cured, and finished, the patient was instructed on cleaning with floss-threaders. At this time the patient was given these specific instructions, since doing this at an earlier stage would possibly have interfered with wound healing. The final, finished PEB is seen in Figure 9; results are quite acceptable, rivaling traditional methods.
